F&B case study's

Meat Grinding Kit Stirchley Burger Company

Stirchley Burgers Meat Grinding kit Trials

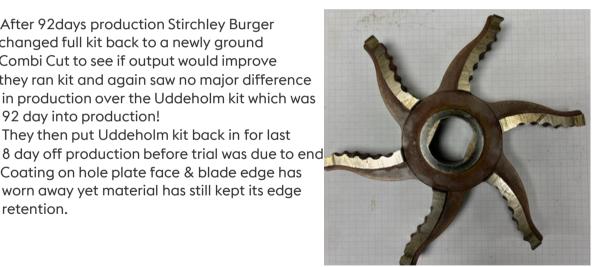
- Pictures below are after 102 days in total production from period between August 2021 February 2022.
- After 92days production Stirchley Burger changed full kit back to a newly ground Combi Cut to see if output would improve they ran kit and again saw no major difference in production over the Uddeholm kit which was 92 day into production! They then put Uddeholm kit back in for last
- Coating on hole plate face & blade edge has worn away yet material has still kept its edge retention.

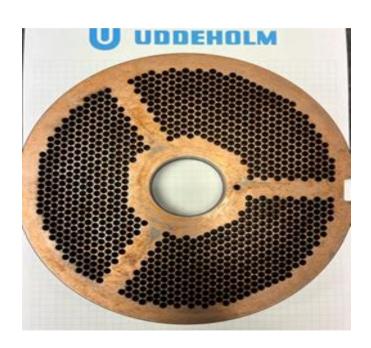
» After 102 days production Non working side on hole plate still in very good condition (coating helps against corrosion)

» Chop Plate After 102 production days. Again non working side in very good condition. Worn face due to star cutter blade rubbing against face. Bushing will help prevent this but customer needs the close contact between components. Like the Star cutter we may next time produce using Uddeholm Caldie @ increased hardness on 58-60hrc.

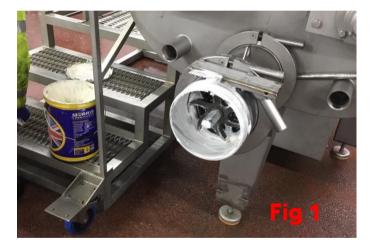
fig 2

» During trial after cleaning kit after production customer coats kit in a lubricant then kit is left over night until production stars again in morning, this lubricant doesn't effect kit (corrosion). Fig 1

The last day of trial was on a Friday when the kit was taken out and cleaned the kit wasn't dried correctly and placed on top of each other which as caused corrosion marks on kit over weekend. This highlights importance of correct handling of kits to prevent corrosion out breaks.

fig 2/3.
