## HPDC – New challenges require new ideas

## How to select the correct die steel in the era of innovation within HPDC

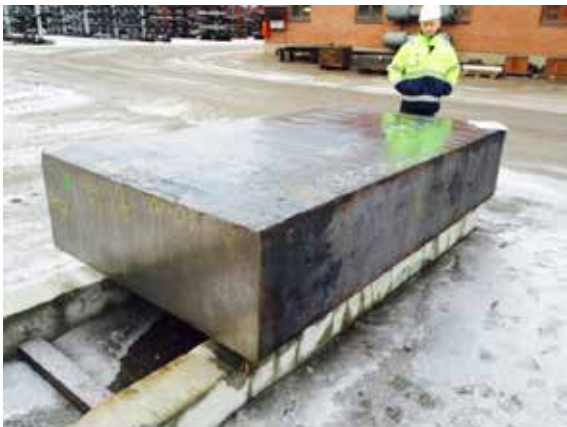
Figure 6, finished 18 ton block of Dievar with excellent results. Testing results across many sizes to the right.

When Uddeholm Dievar was developed, the aim was mainly an improvement of the ductility, toughness, hardenability and heat-checking resistance of dies. Today we see an increasing demand for Uddeholm Dievar, and in sizes which no one could have imagined when Dievar was originally developed. Uddeholms AB has manufactured and tested Dievar in these big dimension ranges, which is shown in the box below (Figure 6) with excellent Charpy-V and grain size results. The blocks have been tested according to the NADCA specification.

In these large dimension ranges, the ductility, toughness and hardenability become even more important, as the figures show in the results box above, for Dievar produced in large cross sections. The desired excellent performance at high temperature, which contributes to the heat-checking resistance, is an additional advantage promoting the use of Uddeholm Dievar.

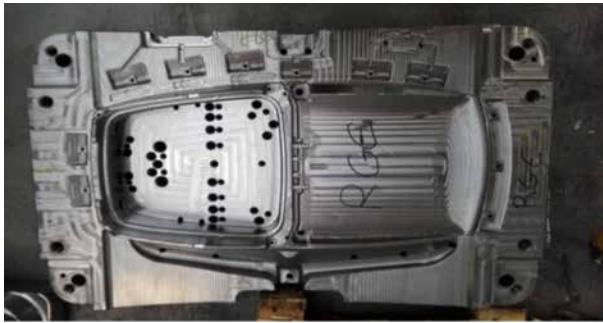
## Case Study - AL - HPDC - Uddeholm Dievar

Figure 7 confirms the laboratory testing that H11 and H13 do not give a vastly different resistance to heat checking and Uddeholm Dievar is still running long after both H11 and H13 have both failed.

However, using the best material available is not a guarantee against early heat-checking problems. Careful concern must also be taken to other parameters such as design, die making, heat-treatment, surface treatment and casting parameters etc. However, if you face heat-checking problems with your tooling when using H11 or H13, then using Uddeholm Dievar is a great start to a successful die life improvement, as the customer case study (Figure 7) shows from 2017.
